**FINAL REPORT:**

**Turkey Beach Shoreline Erosion Management Plan (SEMP)**

April 2020

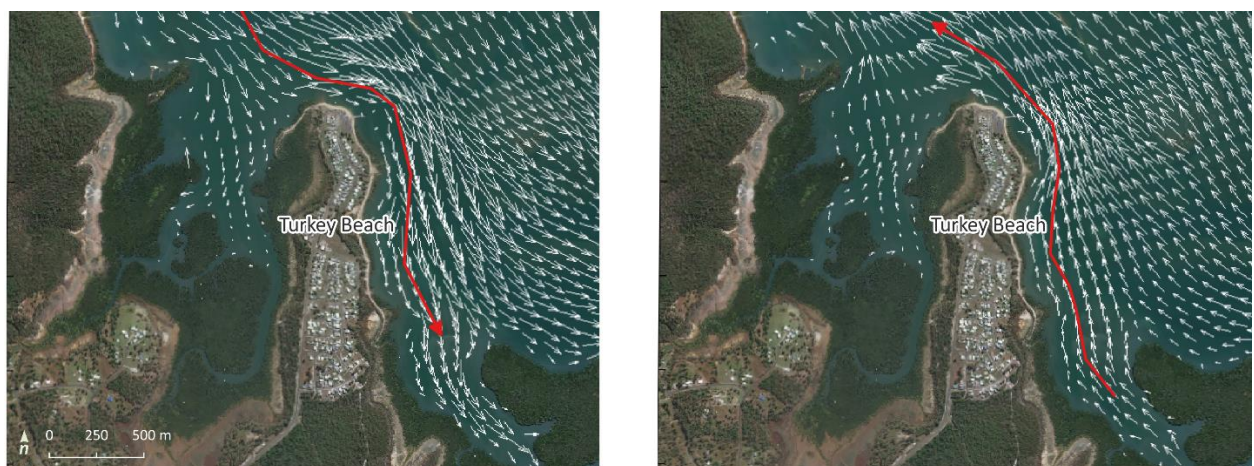
**Figure 10.** *Modelled tidal patterns around Turkey Beach showing peak flood-tide (Left) and ebb-tide (Right) (white arrows) and overall dominant direction (red arrows)*

The northern beach (adjacent to the Esplanade) is prone to strong tidal currents in both directions, with the west and eastern shorelines being more sheltered from tidal currents.

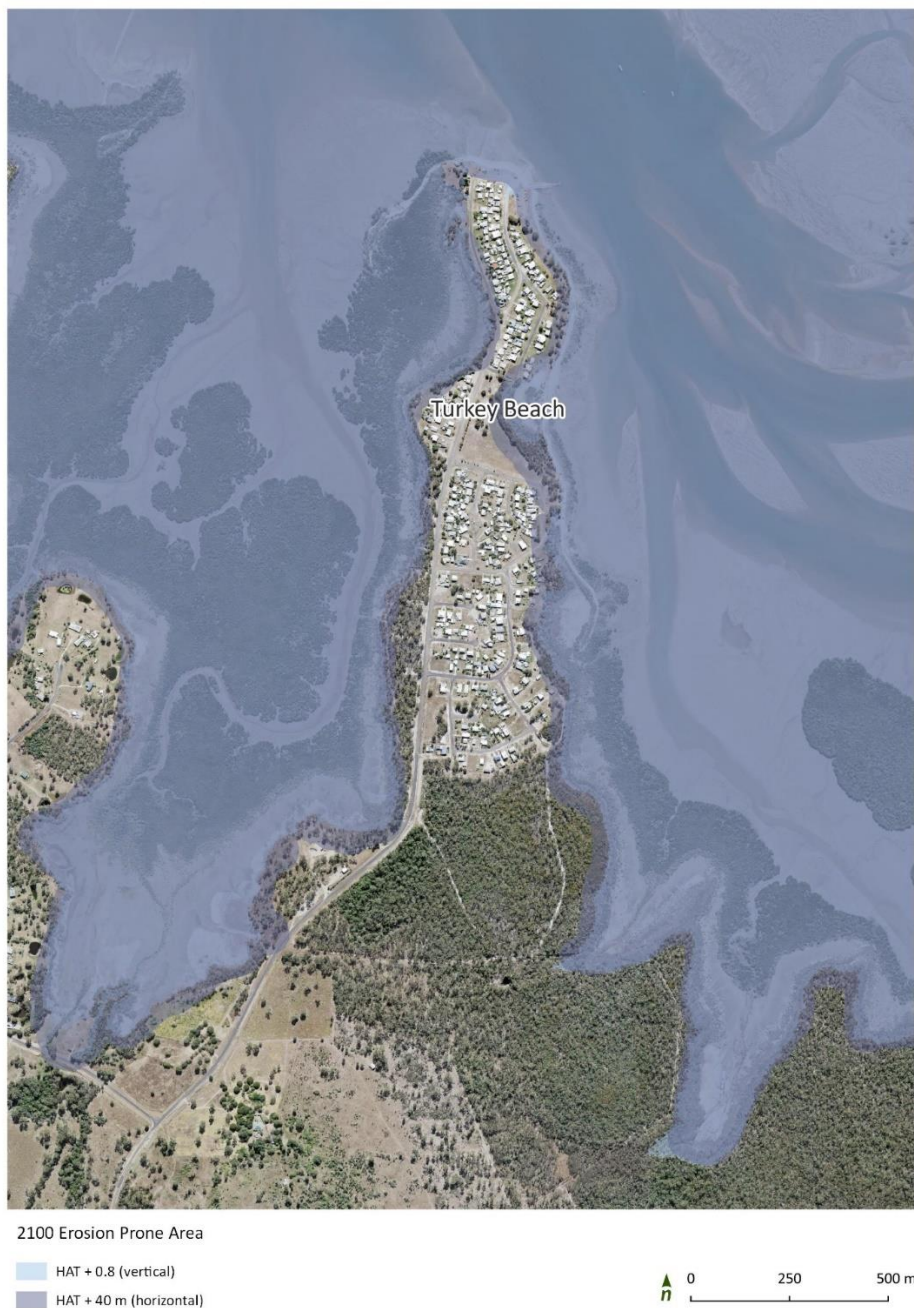
**Figure 14.** State Erosion Prone Area

The EPA extent for the Turkey Beach peninsula includes areas likely to be exposed to tidal inundation by 2100, represented by the combined mapping of Highest Astronomical Tide (HAT) plus 0.8 m sea level rise, and a HAT plus 40 m (horizontal) default zone. The majority of the township is outside of the 2100 EPA, however the shorelines, open space areas and some limited residential areas on the margins are likely to be exposed to increasing tidal areas in the absence of intervention. Longer term adaptation options are considered in the Coastal Hazard Adaptation Strategy currently being developed by Council. For the SEMP process, the EPA assists to highlight areas that may be increasingly prone to the emerging coastal hazards from present day to 2100. Notable areas include the northern point and sections of the eastern shoreline (Figure 14).

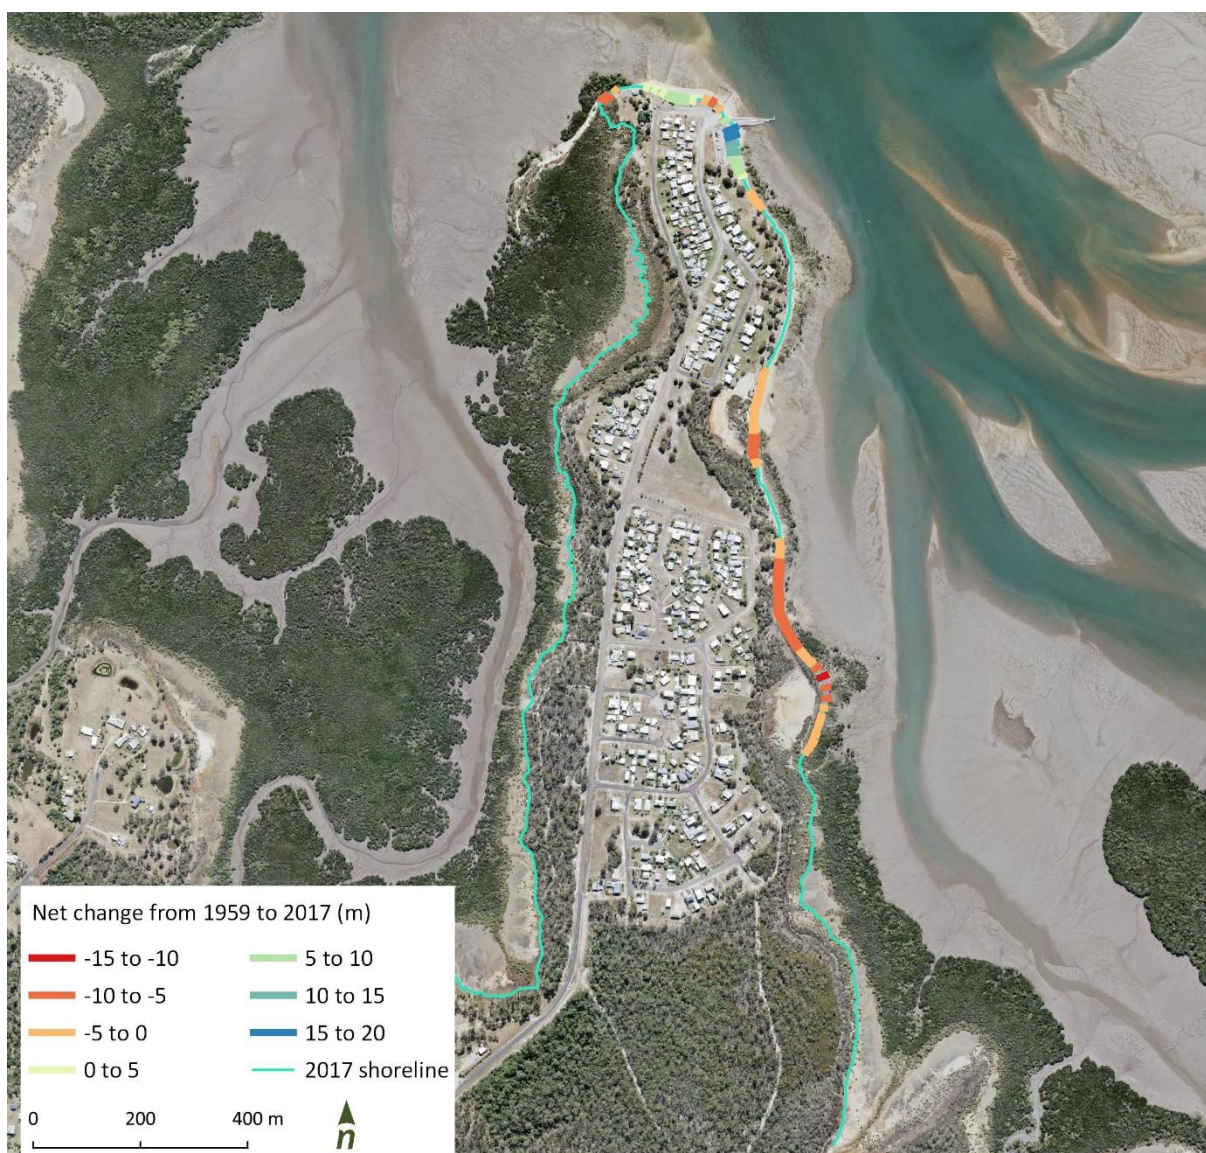
**Figure 16.** Net shoreline movement from 1959 to 2017 (m) – seaward accretion (+ change) or landward recession (-ve change) measured from transects spaced at 20 m intervals along the shoreline

In areas that have experienced recession, the End Point Rate of change (over 1959 – 2017) is relatively low, in the order of 20 cm/yr. Linear Regression Rates of change are also relatively low, in the order of -0.2m to +0.3m per year. Attachment C provides additional detail on rates of change along the full Turkey Beach shoreline.

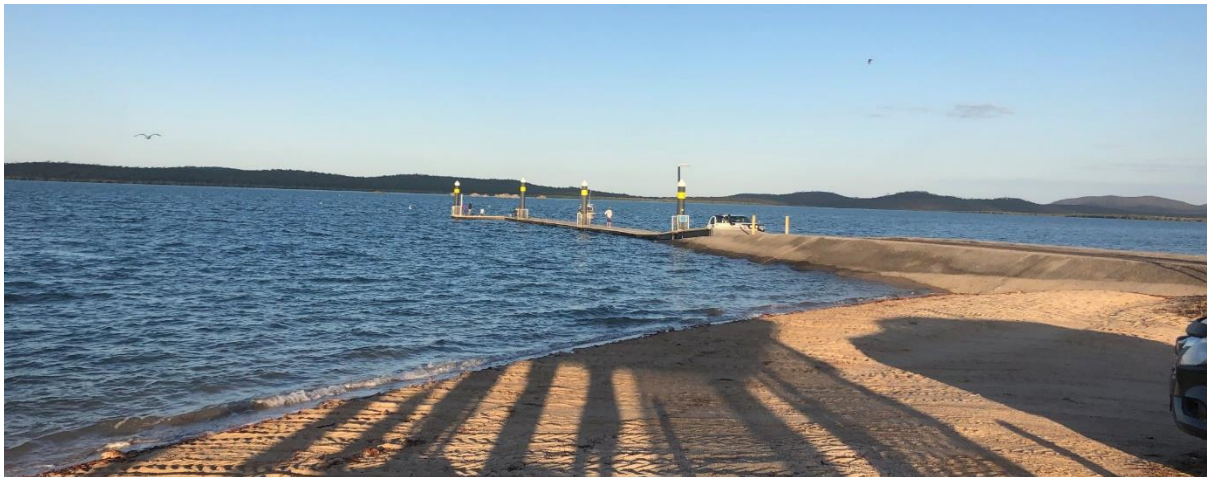
**Figure 20.** Northern point shoreline - Lee (north) side of the boat ramp

Minor erosion is also observed on the lee (north) side of the boat ramp (where minor recession has occurred – refer Section 2.4). The position of the boat ramp intercepts the northerly sediment transport, resulting in a build up of sand on the southern side of the ramp, and less sand reaching the north point shoreline. The lee (north) side of the boat ramp is also used for informal boat access.

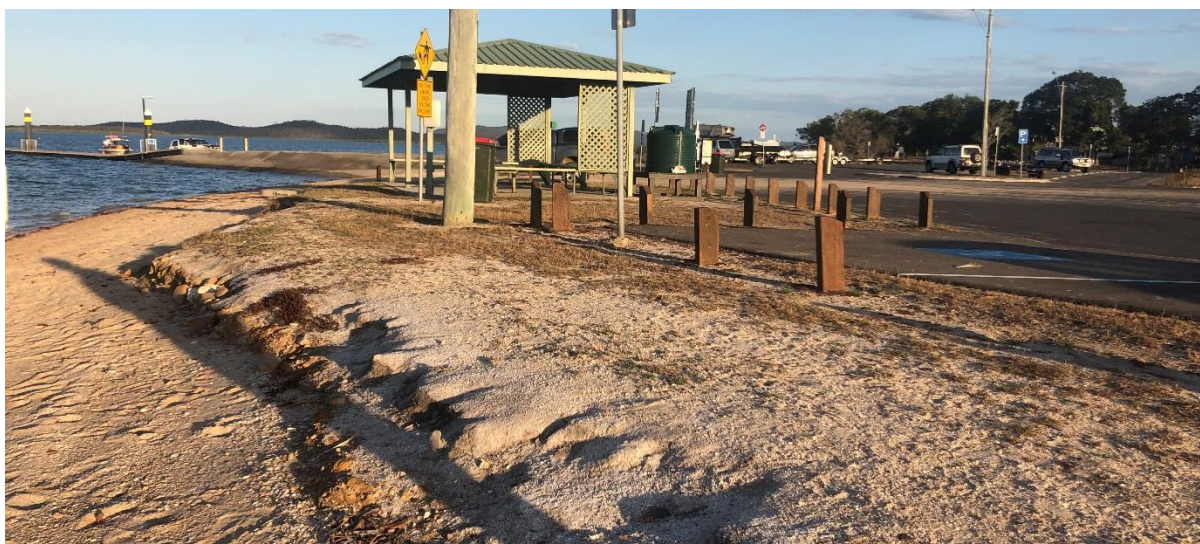
**Figure 21.** Northern point shoreline – erosion scarp behind swimming enclosure

Erosion of the coarse sandy shoreline occurs periodically after storm events, and there is minimal dune re-building / recovery observed between events. As of August 2019 an erosion scarp along most of the beach length was observed, at approximately 0.2 m high. Also visible offshore is a sandbar, running parallel to the shoreline. Eroded sand along this reach is transported to the west (driven by tides and easterly winds – refer Section 2.2), moving around the point and extending the north-west sand bar offshore.

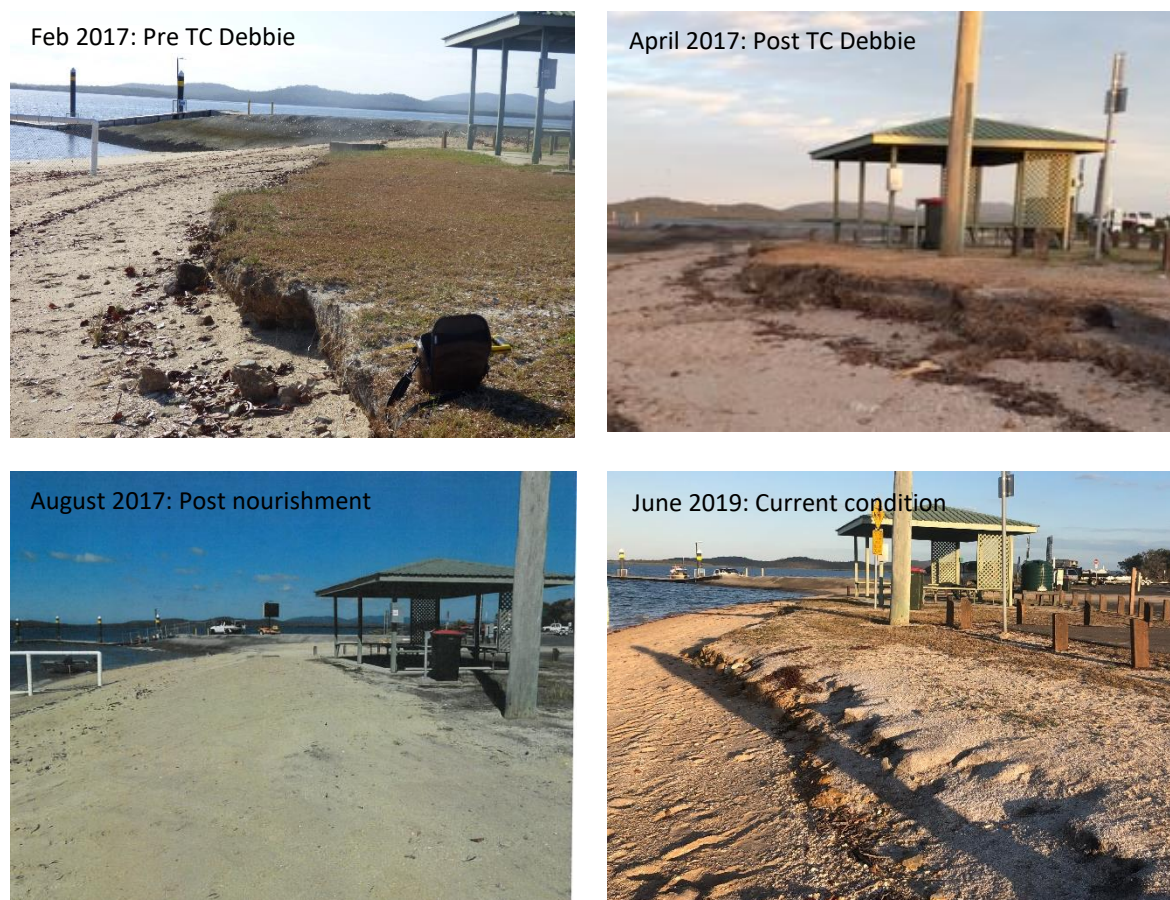
**Figure 22.** Northern point shoreline - Beach profile in front of the boat ramp carpark located on The Esplanade, Turkey Beach – pre and post nourishment (All photos except current condition supplied by GRC)

Beach nourishment via sand scarping was undertaken in August 2017 following erosion during Severe Tropical Cyclone (STC) Debbie in March 2017. Photos of the site condition pre-STC Debbie, post STC-Debbie, post beach nourishment and during the field visit are shown in Figure 22. These photos indicate an erosion scarp prior to STC Debbie, which was exacerbated following STC Debbie. Sand scraping was undertaken in August 2017, in the order of up to 5,000m<sup>3</sup> to restore and smooth the beach profile.

The majority of the nourished volume has since been eroded, with the current conditions (as of June 2019) appearing similar to pre-STC Debbie.

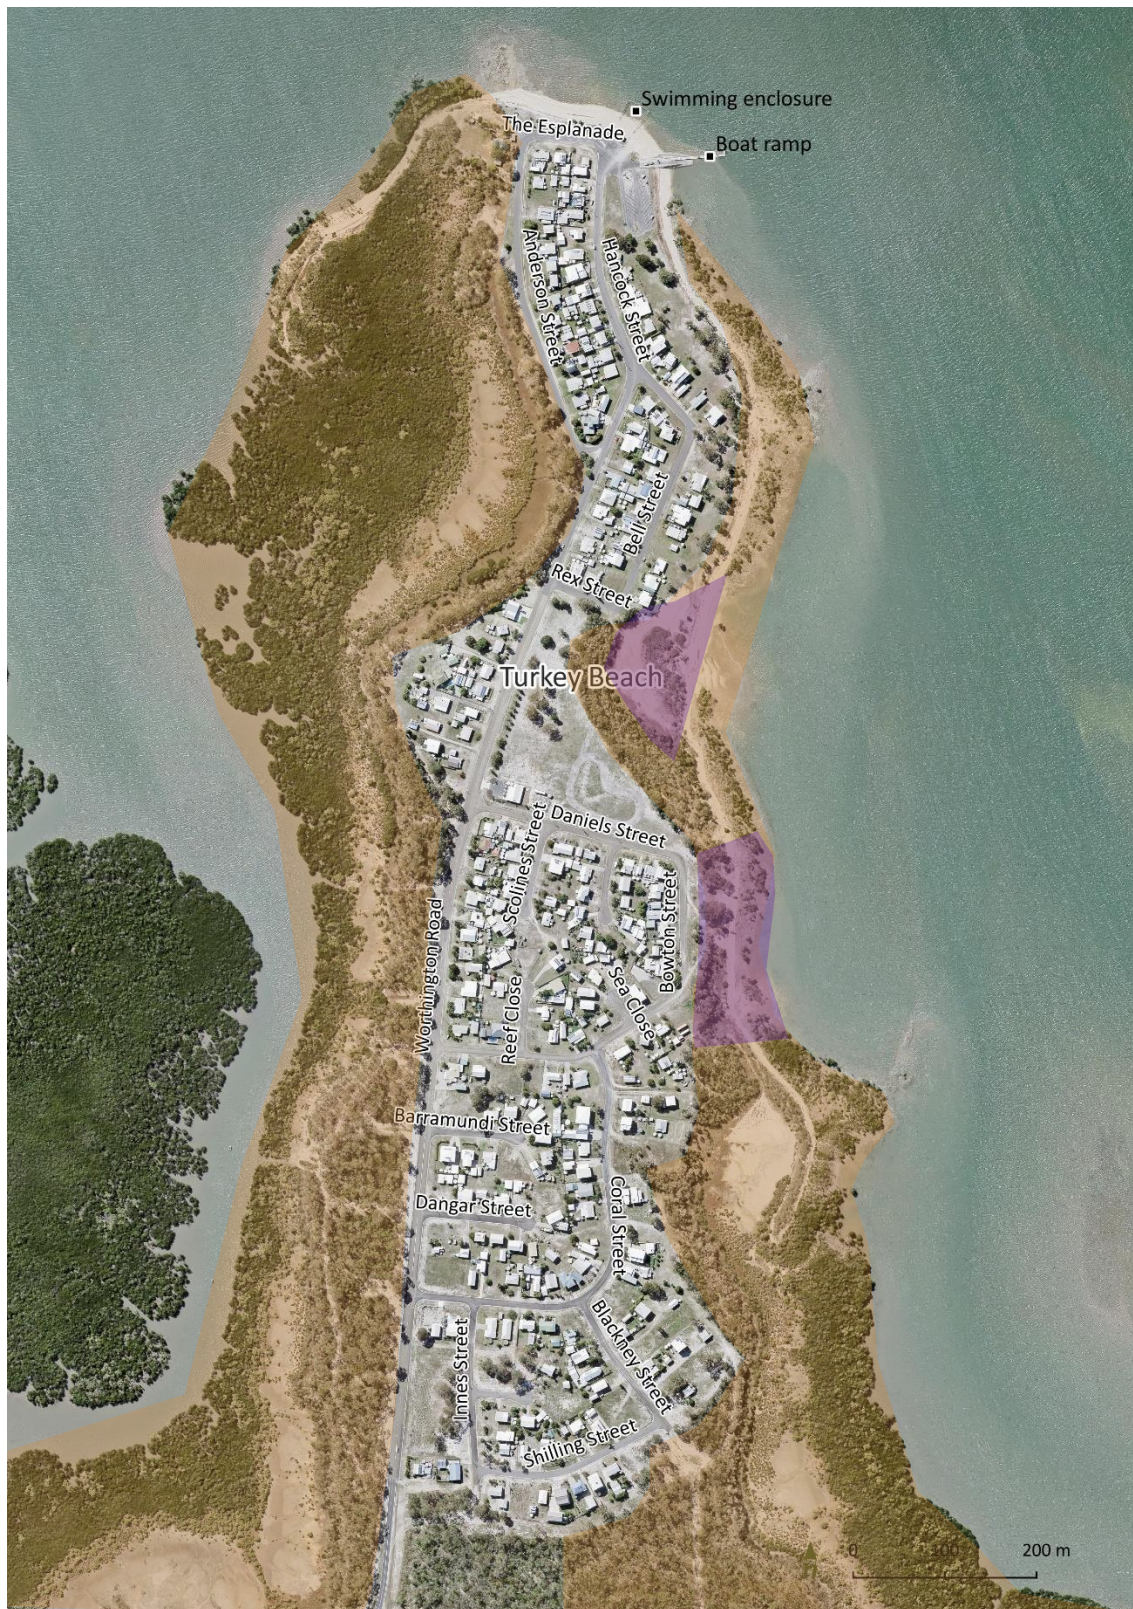
**Figure 31.** SEMP – Part A – Western and eastern shorelines – minimal disturbance zones (orange) where foot and vehicle disturbance should be limited to defined locations - and priority sites (purple) where access should be restricted if feasible

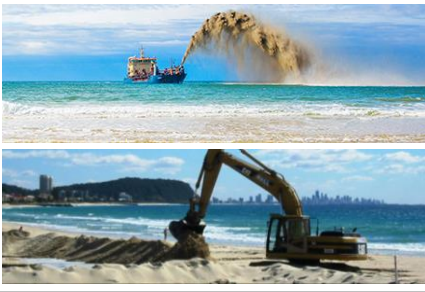
| <p><b>Sand nourishment</b></p> <p>Sand can be sourced from offshore through dredging or other sources and can be imported or sprayed onto the beach to increase the volume of sand on the beach. Sand can be nourished utilising an external sand source (e.g. river mouth or offshore deposits), or sand scraping can be used to redistribute sand already on the beach.</p> <p>Sand can be shaped to provide a dune system that is stabilised with fencing and vegetation.</p> | |

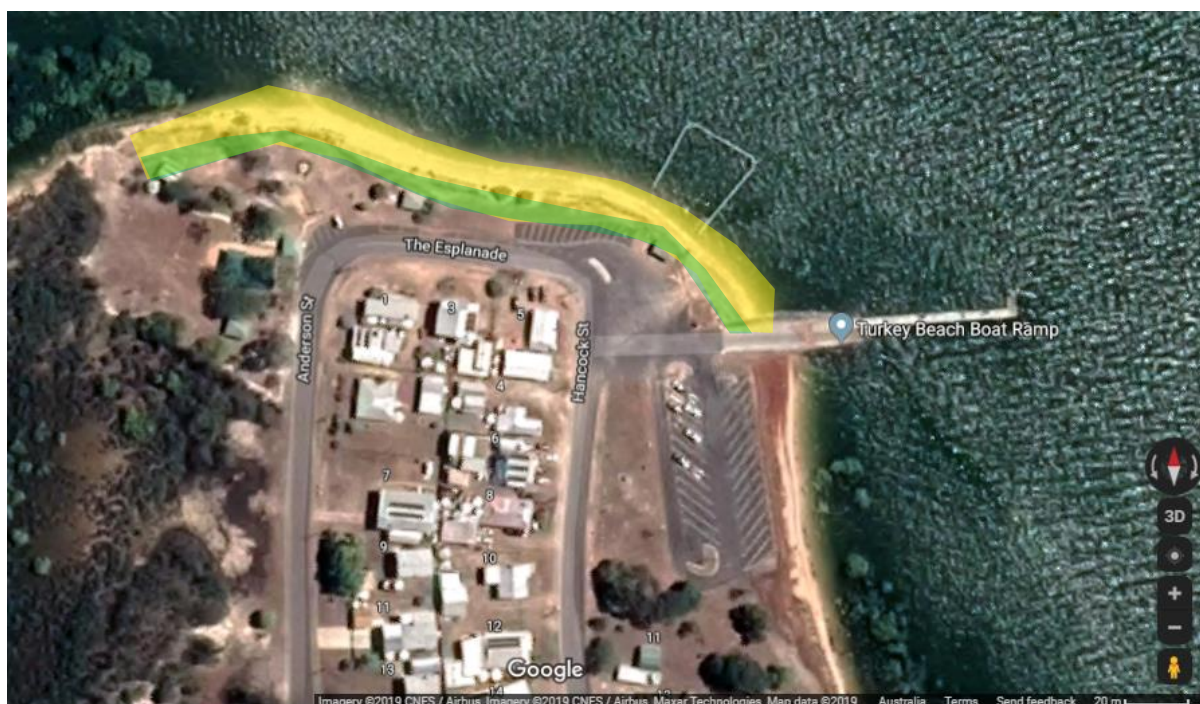
**Figure 32.** SEMP Part B – northern point – beach nourishment and revegetation – indicative nourishment area (4,000 - 5,000 m<sup>2</sup>) and vegetation area (2,000m<sup>2</sup>)

The treatment area and sand volumes estimated for nourishment along the northern shoreline are indicative only, and based on estimated sand volumes that will have longevity at the site and provide protection to the backshore environment from erosion events (i.e. the placed sand is eroded, not the shoreline where assets are located). Alternatively, more localised areas of sand scraping / pushing can be undertaken around the priority areas only (e.g. swimming enclosure, toilet block) as has been previously completed in the past. However smaller sand volumes and treatment areas are likely to be eroded more quickly (possibly annually), and the shoreline will remain vulnerable to major erosion in large events.

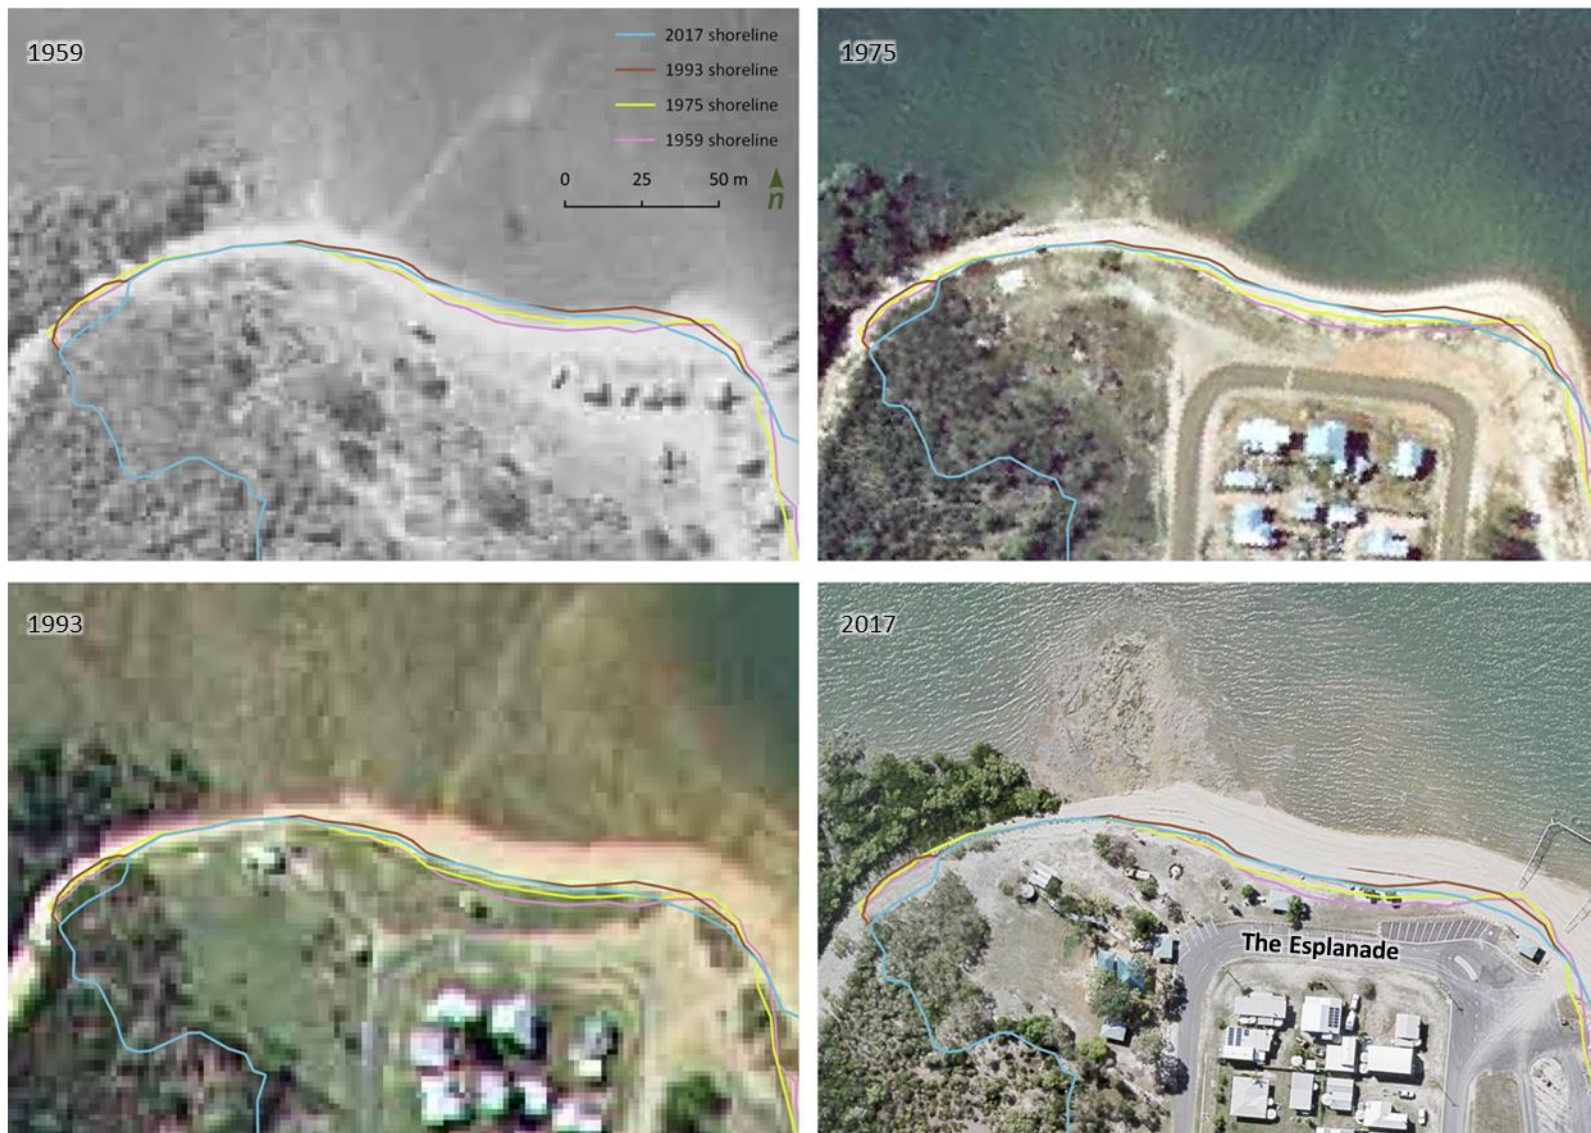
**Figure 36.** Historic aerial imagery comparison and shoreline position for Map 1 – The Esplanade.

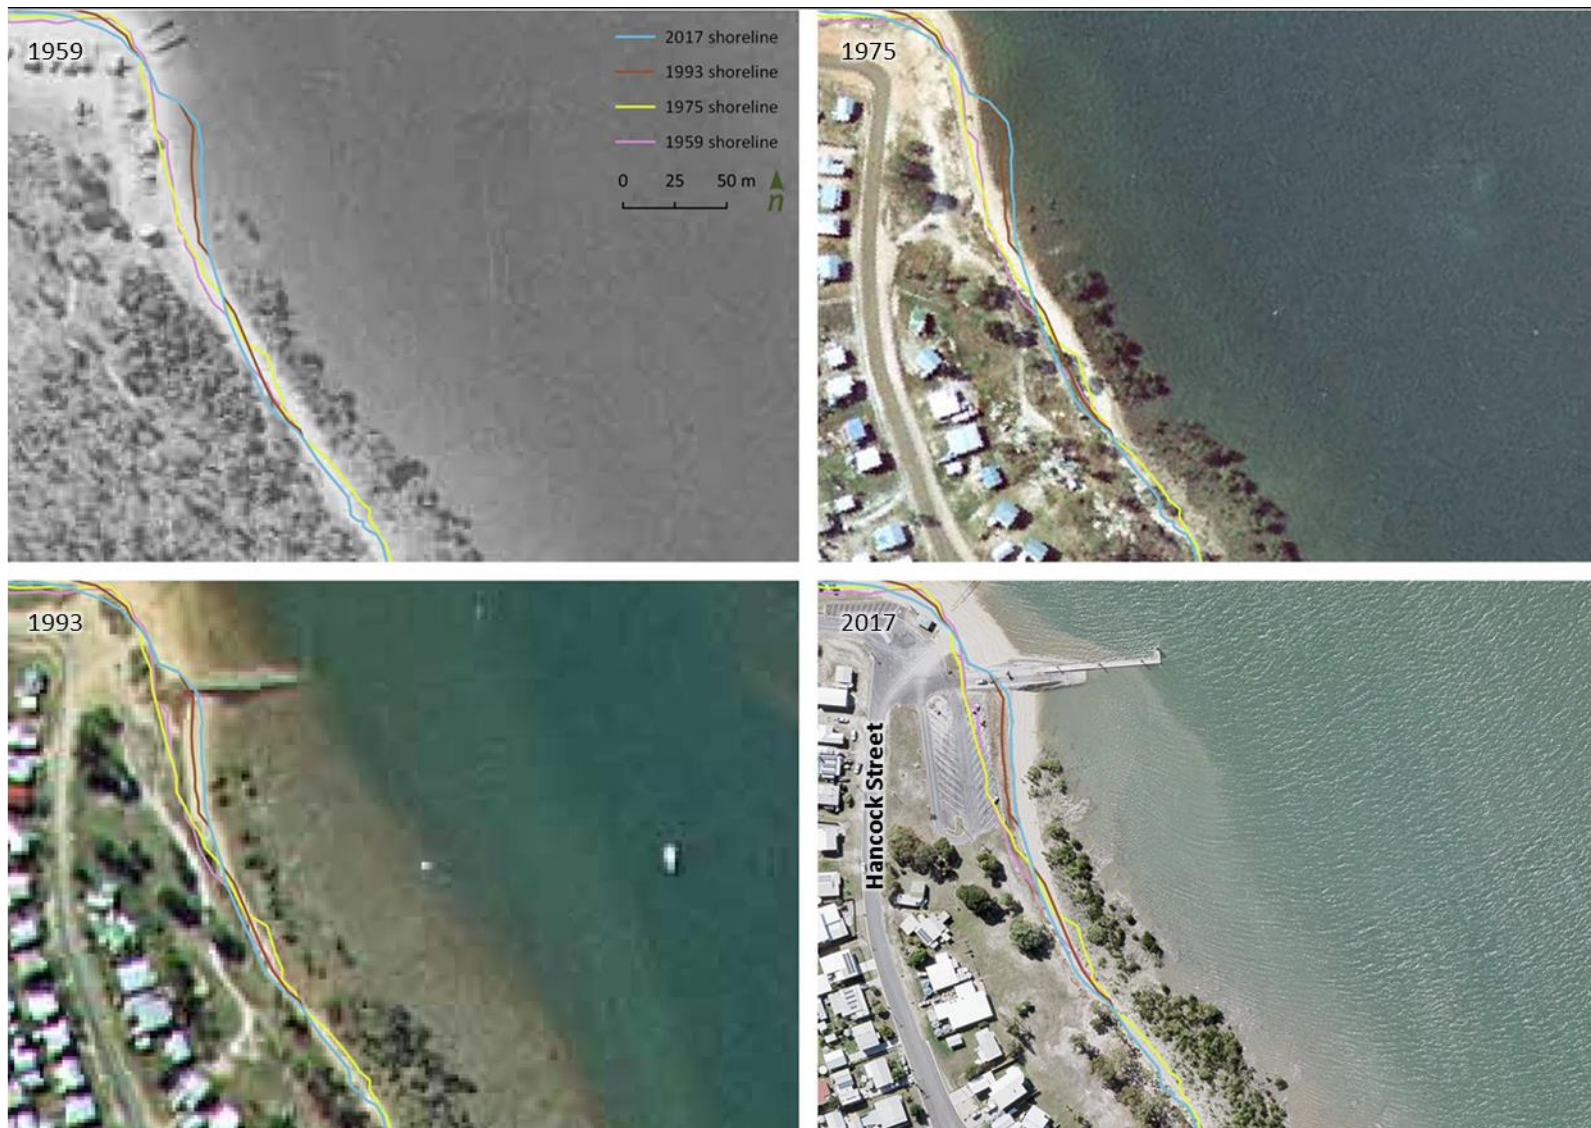
**Figure 37.** Historic aerial imagery comparison and shoreline position for Map 2 – Boat ramp.

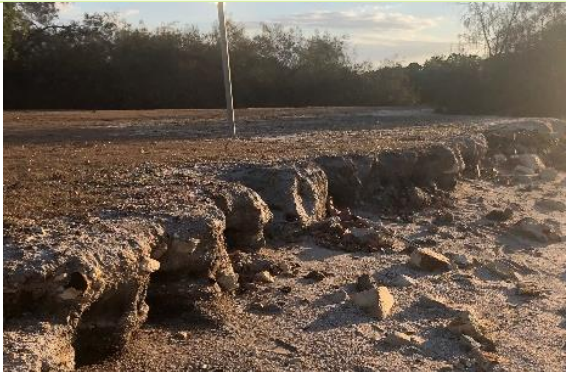
**Table 6. Summary of present shoreline and infrastructure / asset condition adjacent to Turkey Beach Esplanade**

| Adjacent to The Esplanade | |
|---|---|
| <b>Existing condition</b> <ul style="list-style-type: none"> <li>Relatively steep beach with limited vegetation along northern-facing shoreline</li> <li>Scarp present along majority of length of beach, approximately 0.2 m high</li> </ul> | <b>Coastal management and engineering</b> <ul style="list-style-type: none"> <li>Evidence of previous rock protection at western end of beach</li> <li>Visible offshore bar parallel to the beach</li> <li>No clear sediment transport direction</li> </ul> |
| <b>Infrastructure / assets</b> <ul style="list-style-type: none"> <li>Toilet block</li> <li>War memorial (non-Council asset)</li> </ul> | |

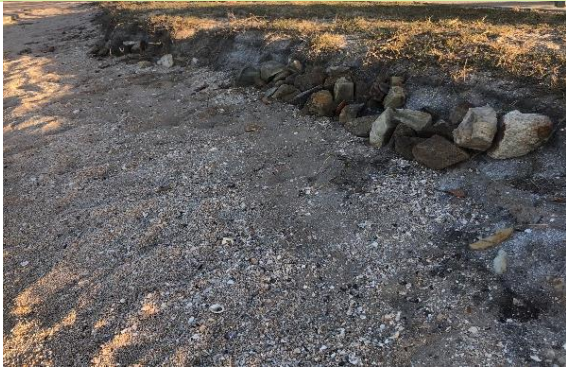
**Table 7. Summary of present shoreline and infrastructure / asset condition at Turkey Beach swimming enclosure and boat ramp**

| Turkey Beach swimming enclosure and boat ramp | |
|---|---|
| <b>Existing condition</b> <ul style="list-style-type: none"> <li>Shallow beach gradient with evidence of sediment loss</li> </ul> | <b>Coastal management and engineering</b> <ul style="list-style-type: none"> <li>Rock revetment covered by sandy beach</li> </ul> |
| <b>Infrastructure / assets</b> <ul style="list-style-type: none"> <li>Boat ramp</li> <li>Swimming enclosure (non-Council asset)</li> <li>Road, shelter and bollards landward of beach</li> </ul> | |

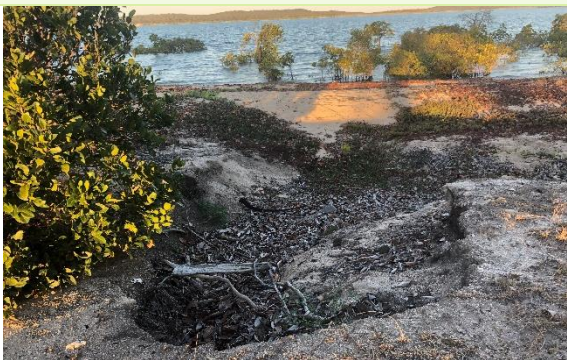
**Table 8. Summary of present shoreline and infrastructure / asset condition at Bell Street, Turkey Beach**

| Bell Street, Turkey Beach | |
|---|---|
| <b>Existing condition</b> <ul style="list-style-type: none"> <li>• Low-lying foreshore reserve with minimal berm</li> <li>• Foreshore receding and scarp behind mangroves ~0.2 m, visible until Brown Street</li> <li>• Watermark (leaves) in clear banks on beach</li> <li>• Stormwater discharges onto the beach</li> <li>• Visible bedrock</li> <li>• Roots of trees exposed</li> </ul> | <b>Coastal management and engineering</b> <ul style="list-style-type: none"> <li>• Mangrove and mudflat in front of the beach</li> </ul> |
| <b>Infrastructure / assets</b> <ul style="list-style-type: none"> <li>• Tidal areas encroaching on property boundaries</li> </ul> | |

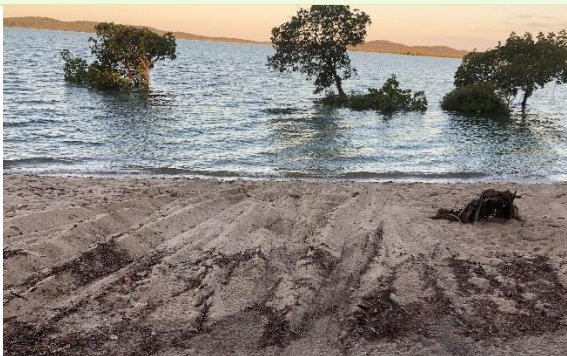
**Table 9. Summary of present shoreline and infrastructure / asset condition at Bowton Street, Turkey Beach**

| Bowton Street, Turkey Beach | |
|---|---|
| <b>Existing condition</b> <ul style="list-style-type: none"> <li>• Mangrove and mudflat</li> <li>• Stormwater discharge south of Bowton Street</li> <li>• Tidal influenced</li> <li>• Some scarping ~0.1 m</li> </ul> | <b>Coastal management and engineering</b> <ul style="list-style-type: none"> <li>• Signage regarding tidal inundation and soft sands to deter vehicle access</li> </ul> |
| <b>Infrastructure / assets</b> <ul style="list-style-type: none"> <li>• Some timber fencing as part of mangrove and vegetation management</li> </ul> | |

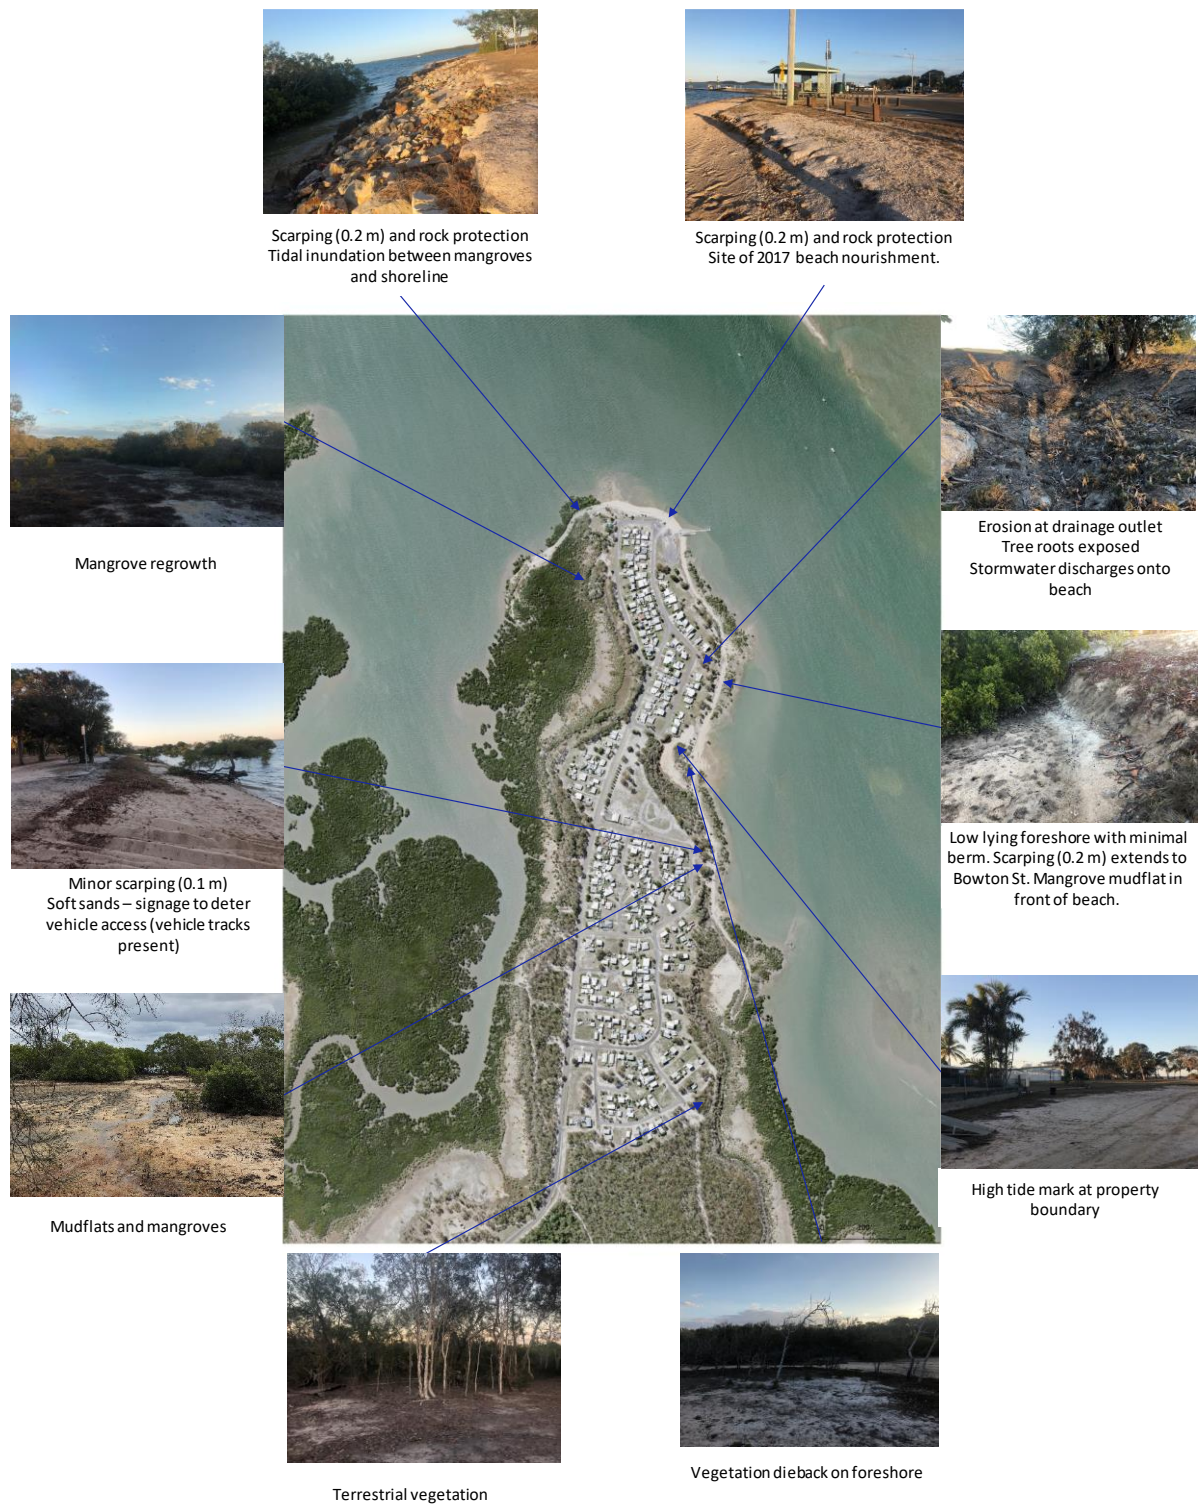
**Figure 41.** *Summary of key site inspection observations*
