RAIL TRAIL Project Masterplan

DRAFT - FOR DISCUSSION PURPOSES ONLY | BOYNE BURNETT INLAND RAIL TRAIL - CONCEPT DESIGN | Project Maskerplan | G3491 | Page 19 | 2021-07-07

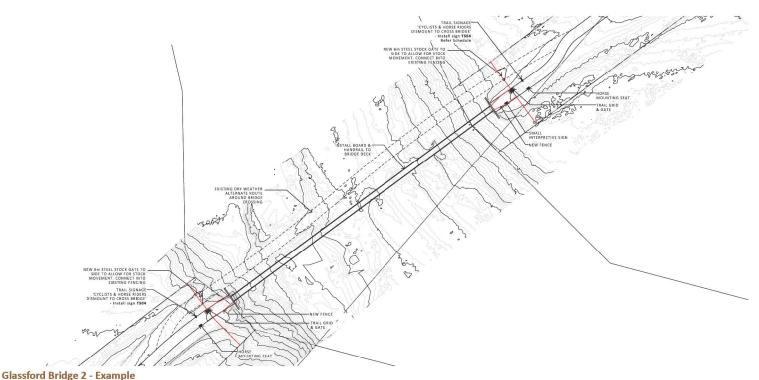
Glassford Bridge 2 - Example

Board and Handrail bridge conversion

To facilitate the conversion of bridges it is proposed to install a lightweight, modular steel and aluminium board and handrail system to allow people to safely traverse the bridges. It is recommended that cyclists and horse riders dismount when crossing the bridges. This allows the handrails of the bridges to be kept lower, keeping cost down and maintaining views from the bridge for walkers.

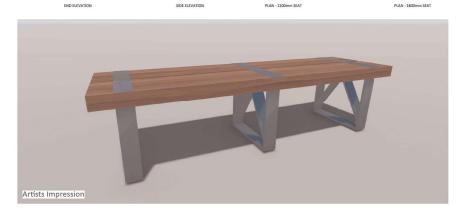
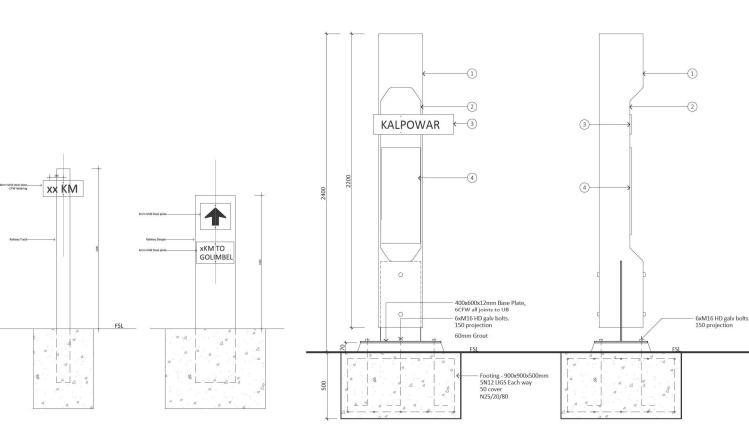
Detail - Seating

NOTES: (1) TIMBER TOP: Ironbark. 240 x 68mm rough sawn with arrised edges Finish: Wire brushed and Light Sanded finish. No Oil to achieve "aged" look 2 STEEL TOP STRAP: 80x12mm Steel strap inlayed into both timber lengths, to finish flush Finish: TBC TOP FIXING: 4x 2 inch "Common Rose Head Nails" per steel strap. Steel to be predrilled to accept nail penetration BASE: 80x12 flat plate steel frame. CFW at each join at each join. Finish; TBC - 2 per 1200mm seat - 3 per 1800mm seat

- TIMBER POST ROUND: Ironbark Bush Pole. 300-350mm diameter fixed to frame with 4 M16 4.6/S Bolts. (2 top, 2 bottom) Finish: Wire brushed and Light Sanded finish. No Oil to achieve "aged" look

ROUTED 'HOG BACK' STYLE CAVITY:
- 3 LOCATION SIGN:
 One for each town. To both sides of sign.
 Lettering: 3mm, Laser cut,
 Powder-coated Aluminium plate
 mounted on the backing plate to sizes
 shown on details. Colour: TBC
 Backing Plate: 3mm Galv. Steel Plate to
 sizes shown on details.
 Fixed to Timber Sleepers with vandal
 proof screws
- 4 SIGNAGE PLATE: 600x420mm (A2 Paper size) signage panel - Artwork and materials TBC Fixed to Timber Sleepers with vandal proof screws
